Test TB31 of BS EN 1317 Parts 1 & 2

Test Number: TRL068

Trief Kerb and Pavement

TEST TB31 OF BS EN 1317 PARTS 1&2

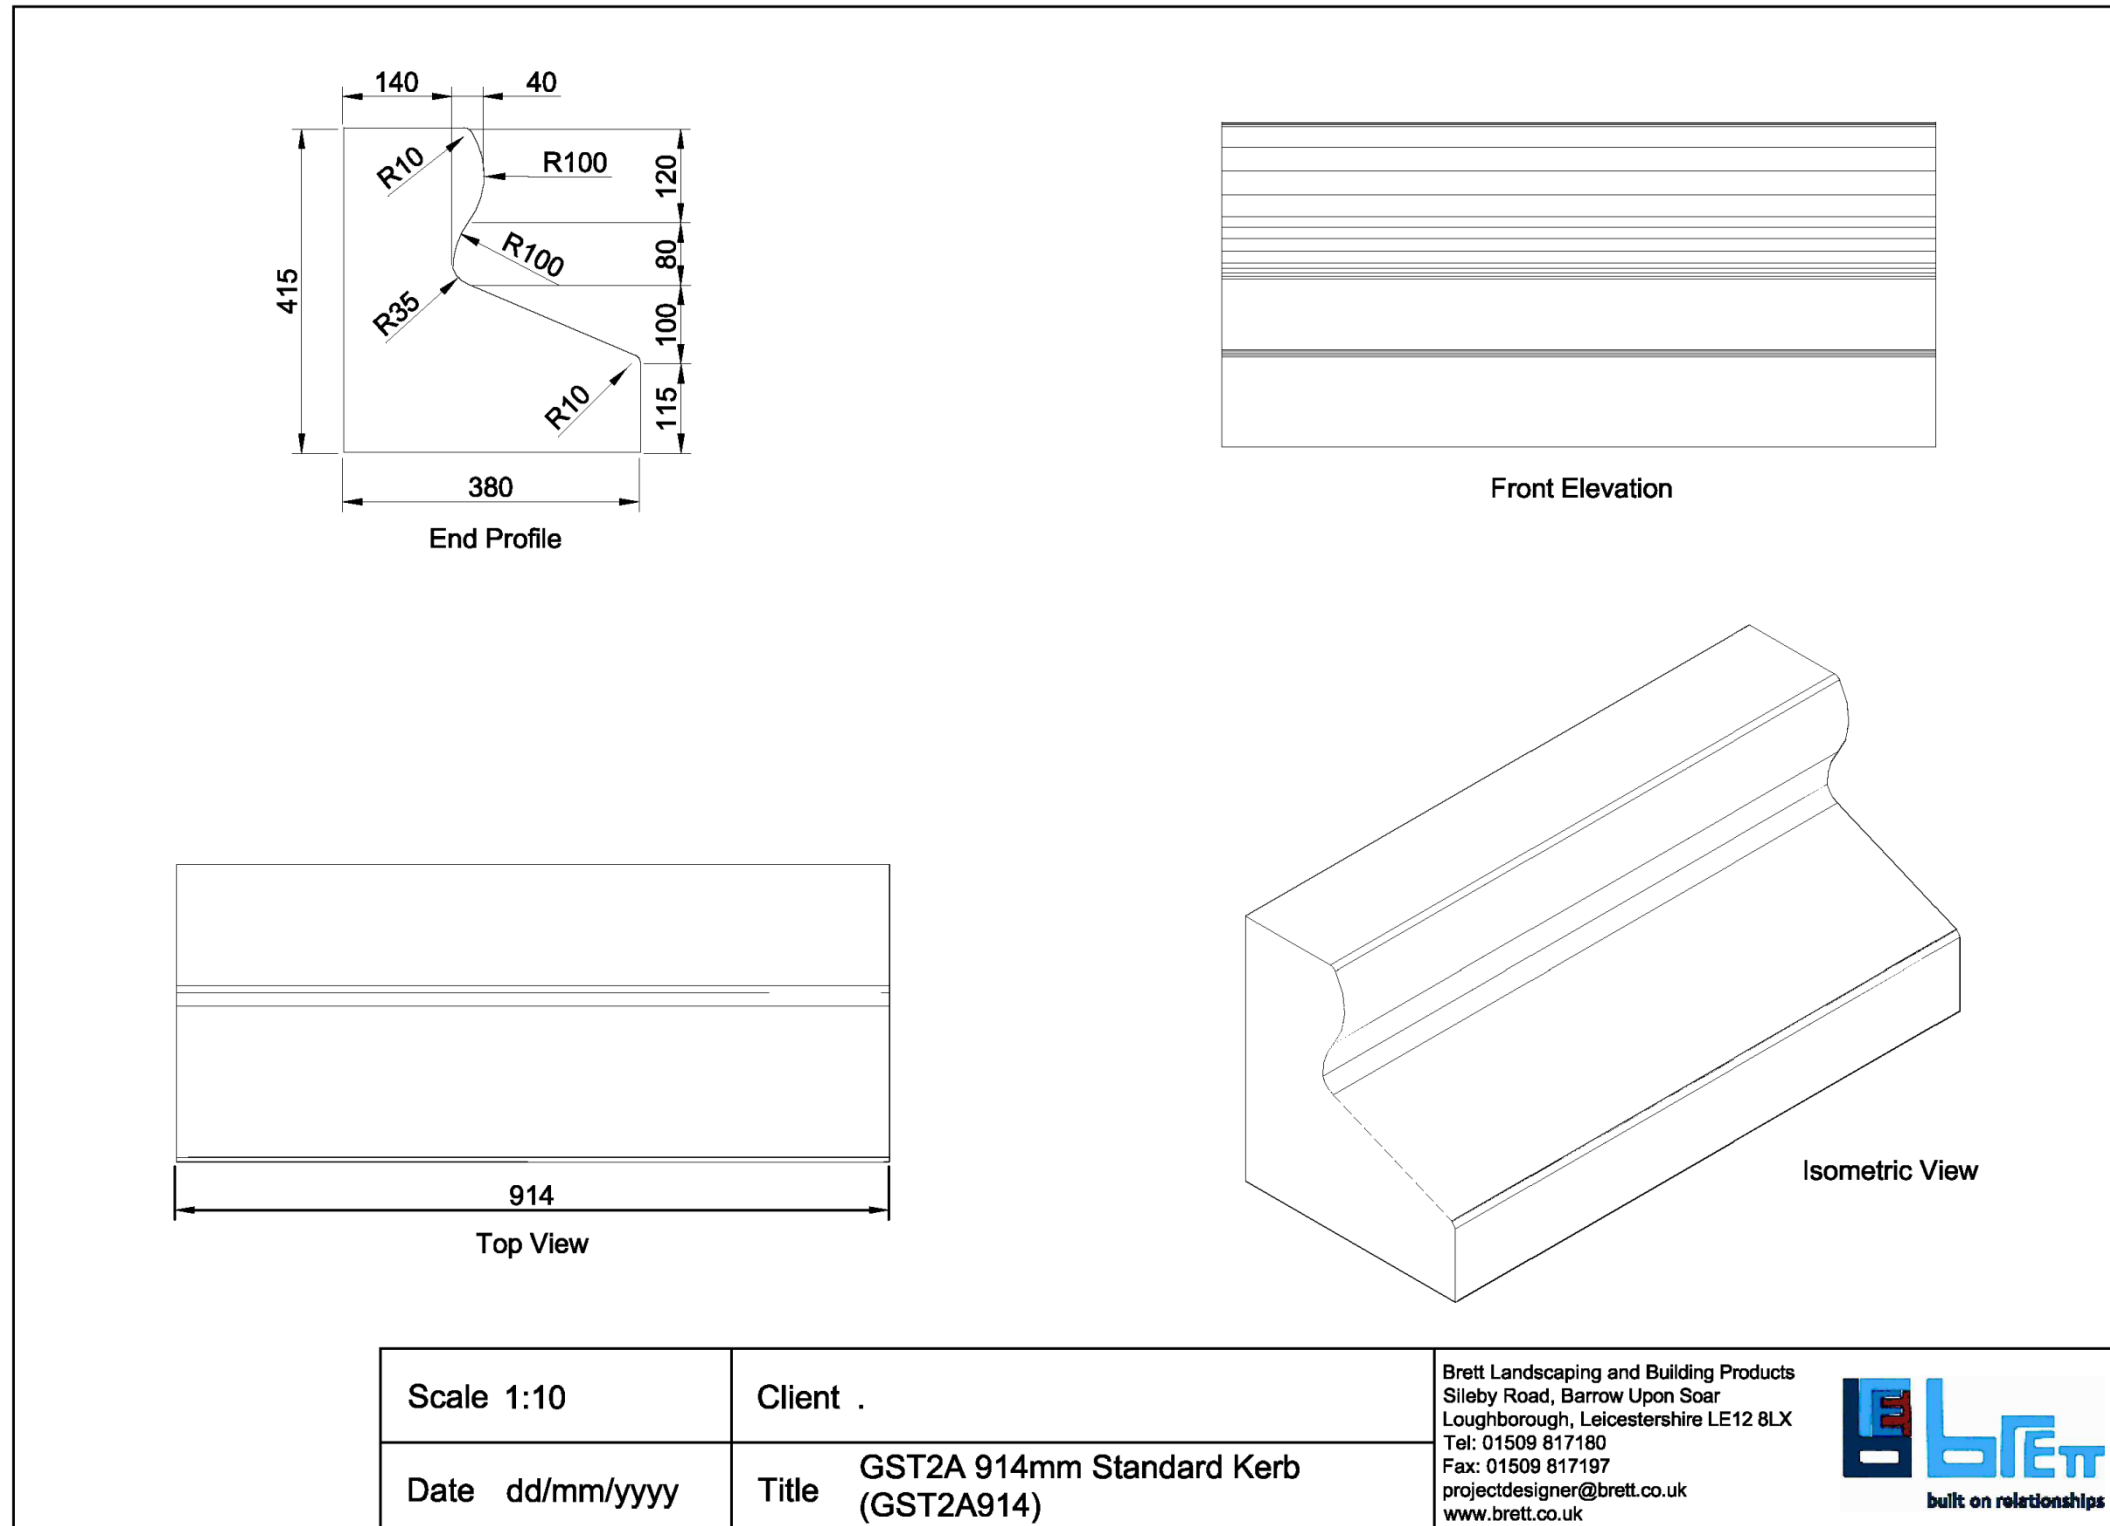
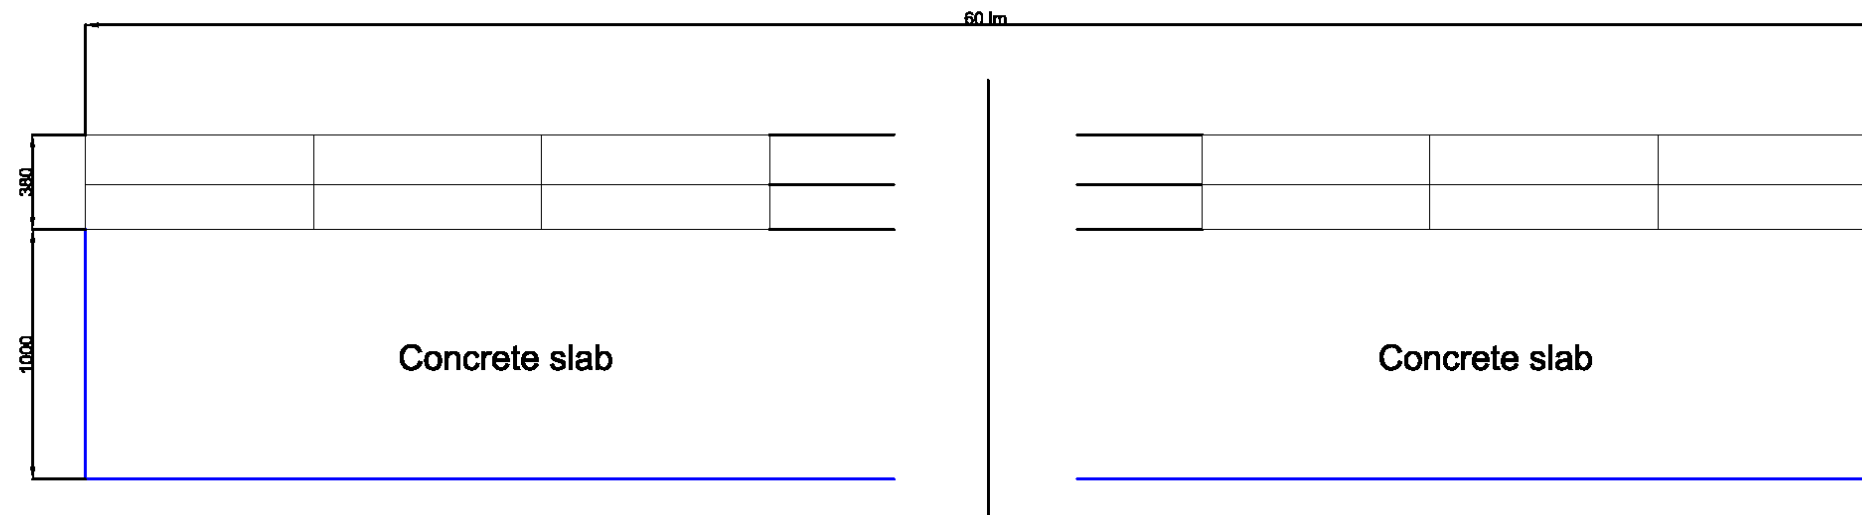
10. ANNEX A - DRAWINGS AND INSTALLATION OF THE TEST ITEM

TRL Note: the drawings provided by the client describe a 60m long system; this length was subsequently revised to the tested system length of 30.33m.
